AIRCRAFT ACCIDENT REPORT

EASTERN AIR LINES, INC
DOUGLAS DC-8, N8607
NEW ORLEANS, LOUISIANA
FEBRUARY 25, 1964

SYNOPSIS

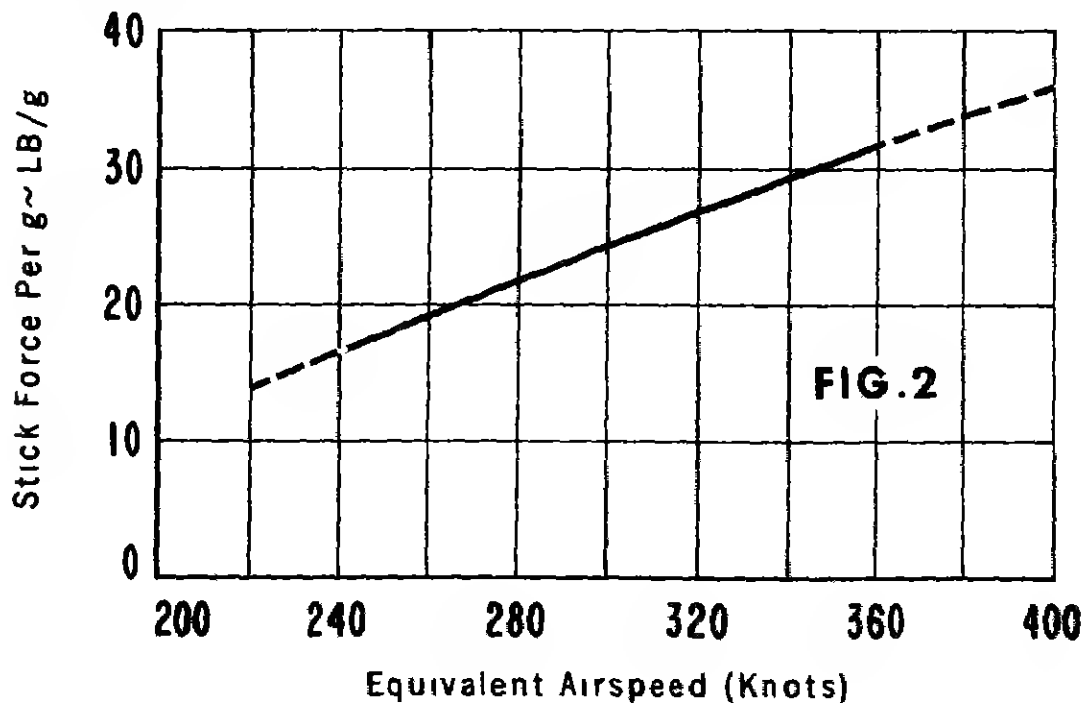
ATTACHMENT C

The variation of stick force per g versus speed for the 2-degree AND case, shown in Figure 2 of Attachment C, is also significant. It should be noted that while the stick force per g is light but at a reasonable level at 310 knots, it degenerates to about 13 pounds at 220 knots. This level of force gradient is extremely light^{10/} and is, to a large extent masked by the friction forces of the system which are about 5 to 6 pounds. Thus, at 220 knots a pilot could maintain a 1.5-g maneuver without feeling any resistive force, or he could hold limit load (2.5-g) by feeling out only about 14 pounds, considerably less than required for a similar maneuver in a military fighter aircraft.
